**UNITED STATES ENVIRONMENTAL PROTECTION AGENCY**  
**REGION 10**  
1200 Sixth Avenue  
Seattle, Washington 98101

**Dive Dates: June 5-7, 2012**

**Project:** Quartermaster Harbor – Maury Island Aquatic Reserve

**Overall Objective:** Survey of moorage buoys systems for potential impacts to aquatic reserve habitat.

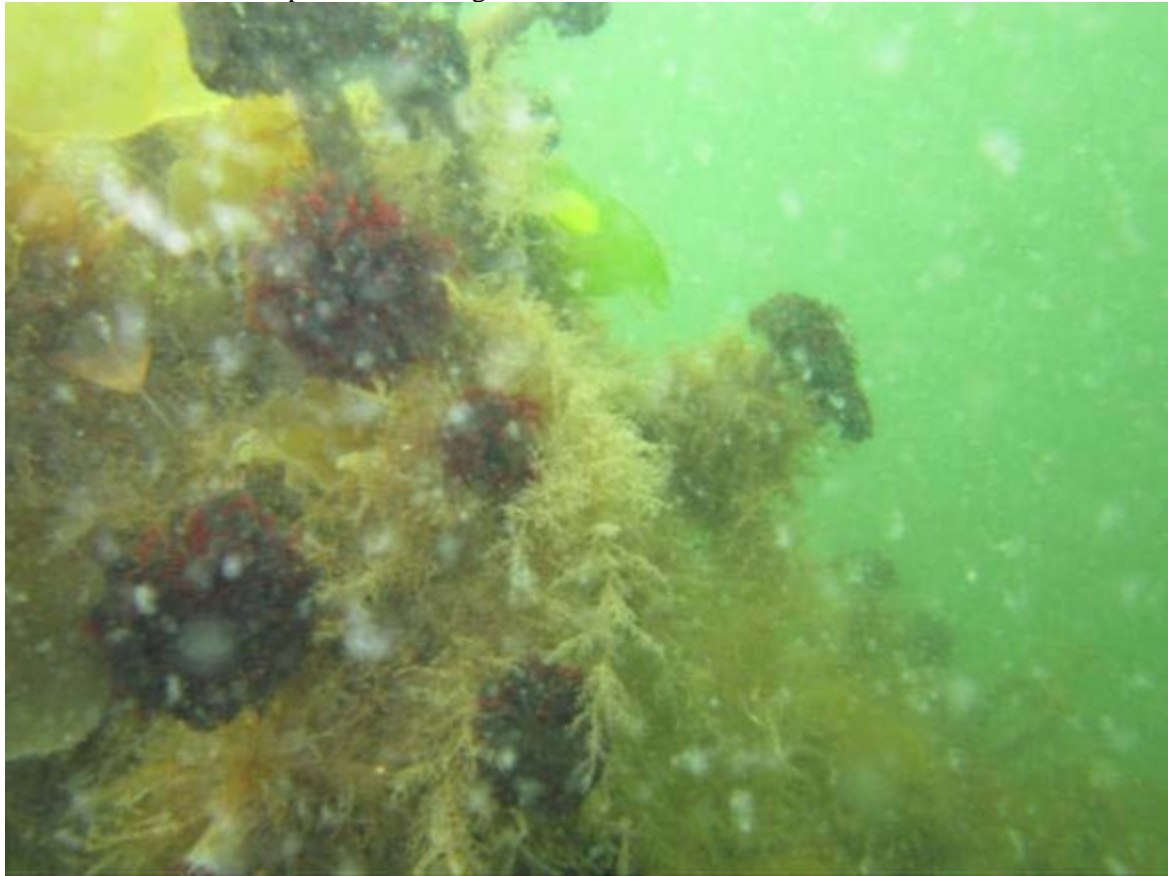
Marine life on shallow part of mooring line.

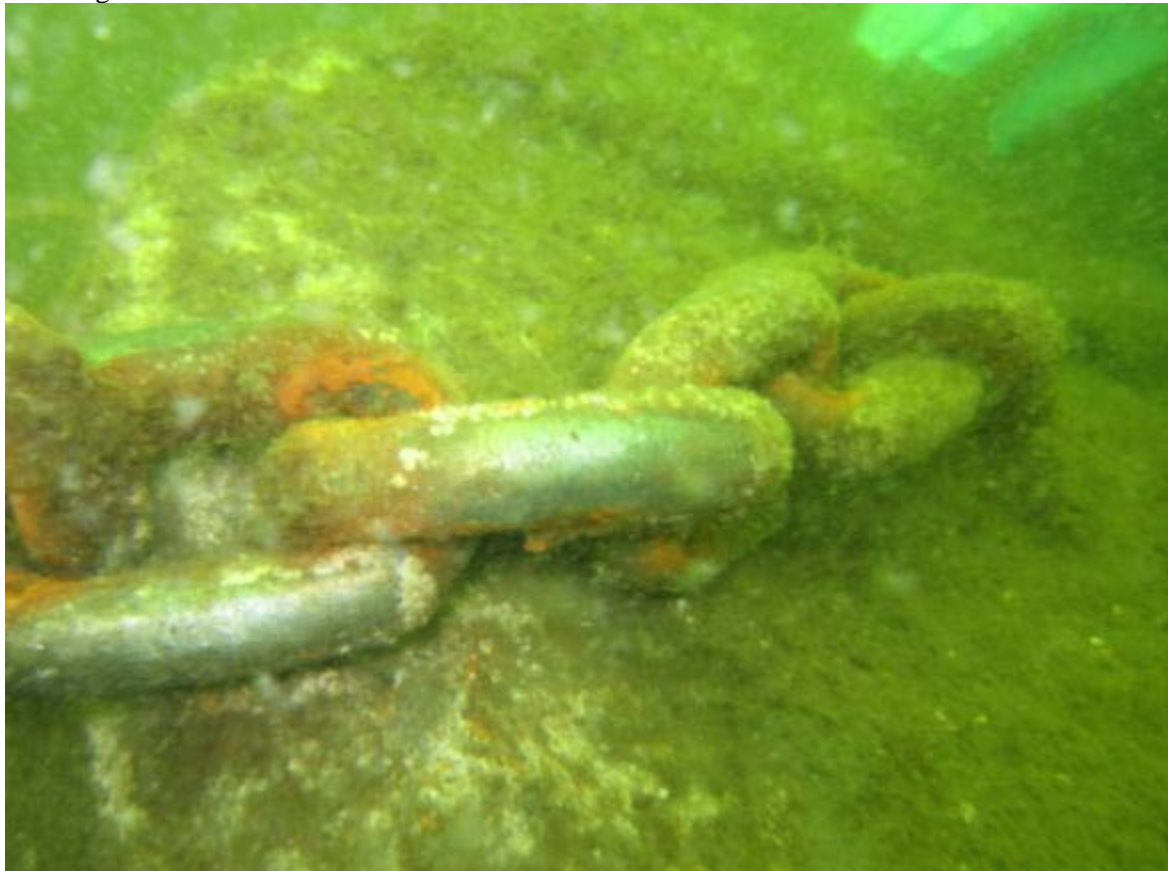
Mooring chain on an anchor.

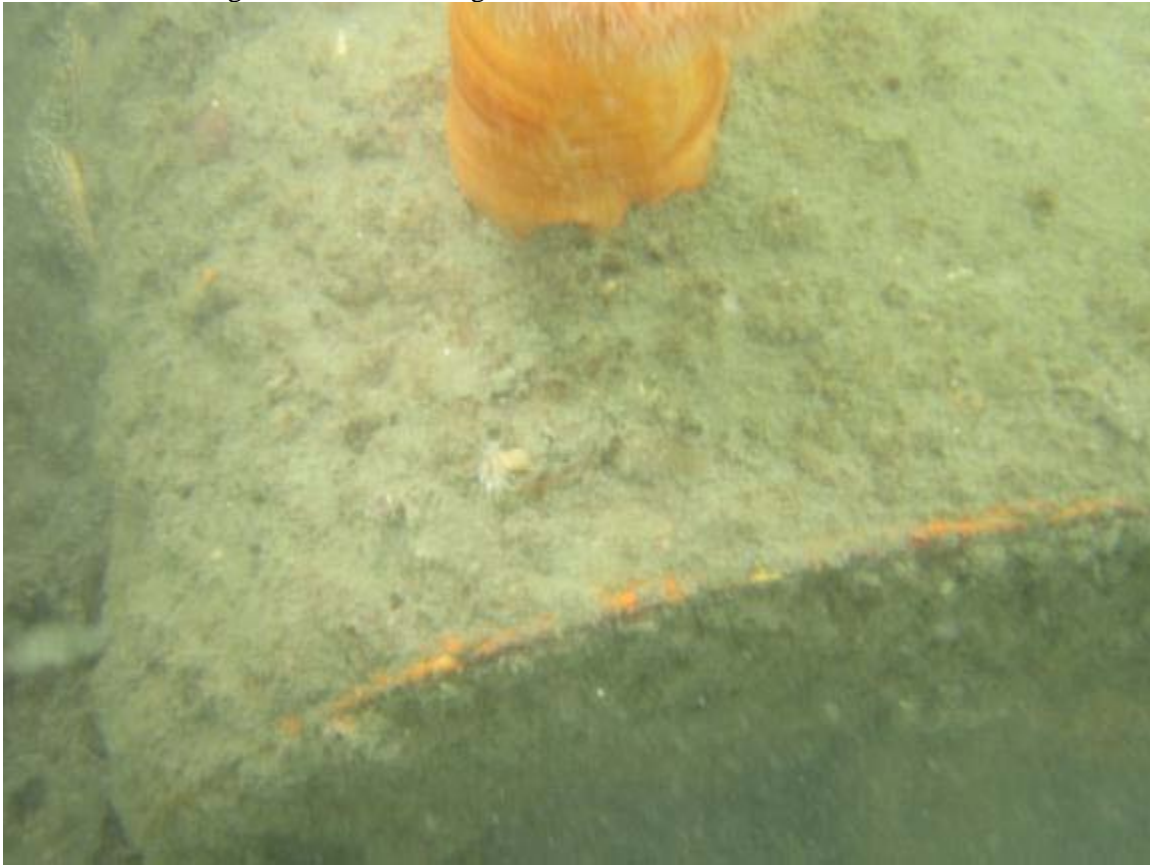
Concrete filled 55 gal. drum – mooring anchor.

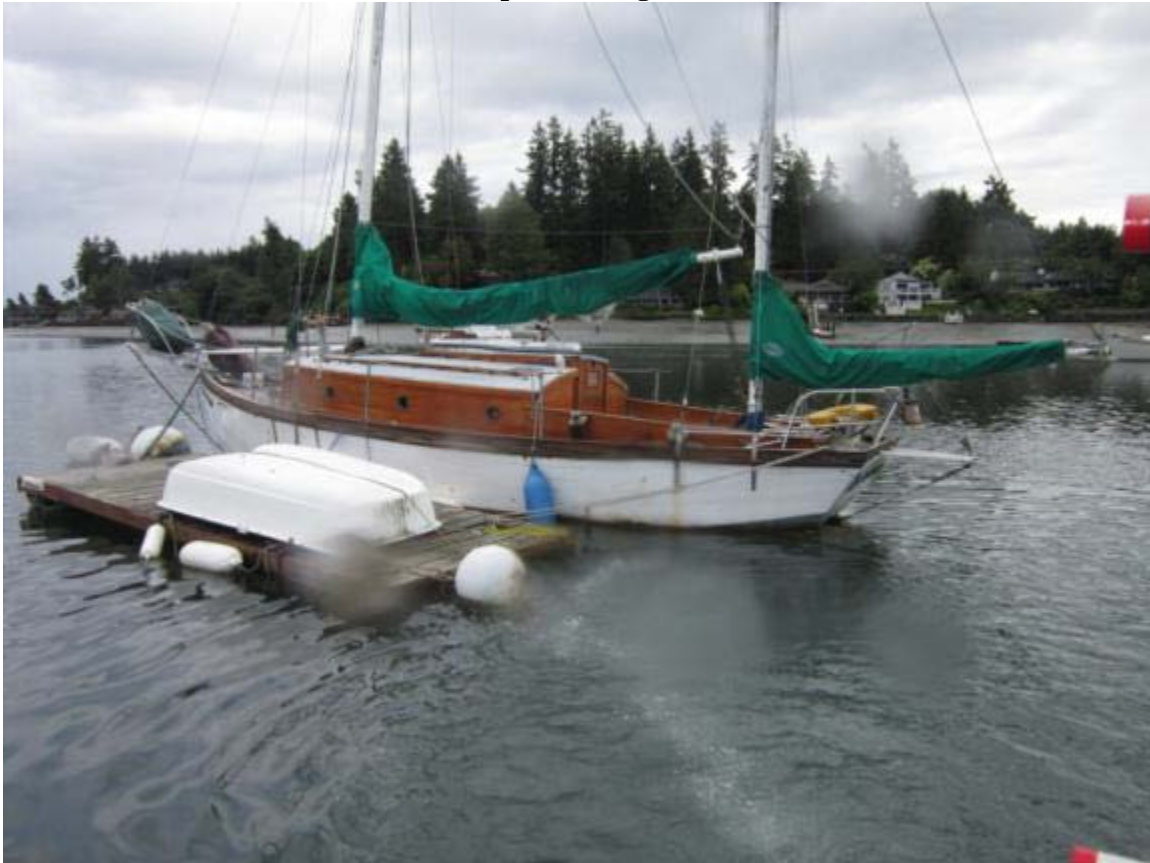
**Burton Cove – boat and float with multiple mooring anchors.**

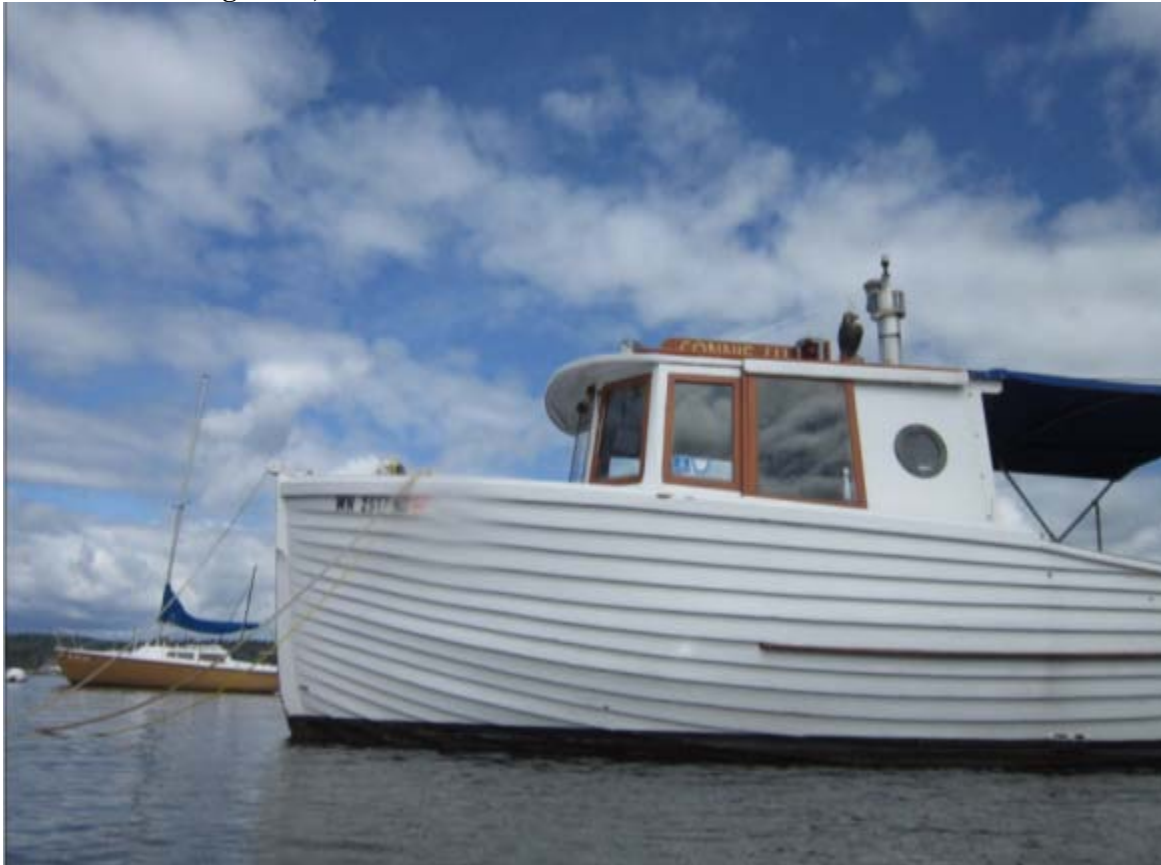
**Boats and mooring floats, Dockton Cove.**

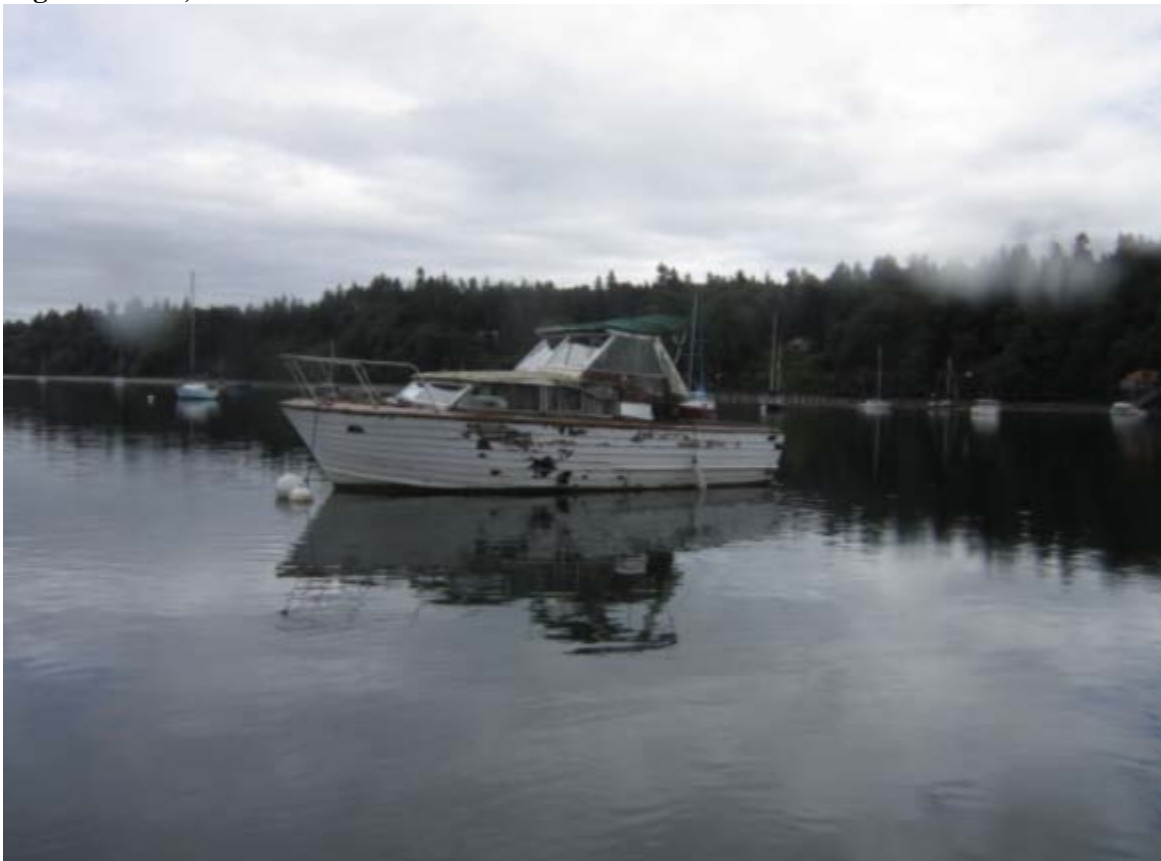
**Neglected boat, Dockton Cove.**
